**Flood Control Project Maintenance
Levee Inspections**
LMA District Cover Sheet
Spring 2018 Levee Inspection Results

Levee District No. 0001 (Glenn County)

Spring 2018 Levee Inspection Results

Waterway			Bank	Unit Miles
Unit No. 01 Sacramento River			Right	12.23
	Spring (March - May)	Summer (June - August)	(September - November) Fall	Winter (December - February)
Unit Maintenance Rating (Fall Only)				
Date of Inspection	3/8/2018 - 3/8/2018			
DWR Inspector	Bob Duffey			
Accompanied By	Jason Enos LD1G

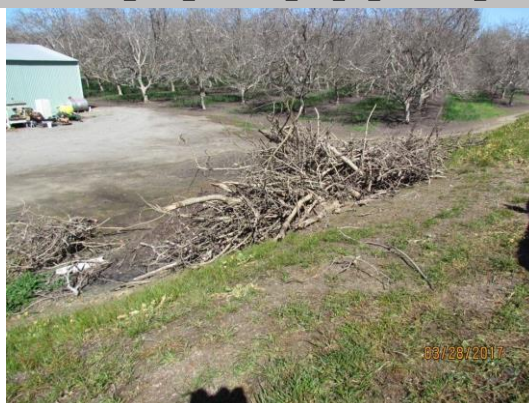
Photo 1 of 1 : SP_2018_LD0001G_432_40_20180305_00010.jpg

LM Start	0.05	Rating **	M	Issue No.	40
LM End	0.05	Issue Type +	En	Location *	LS
Category	Earthen Levee			GPS Latitude/Longitude	
				Start	End
Item	Encroachments			39.477833 °	39.477833 °
				-122.017484 °	-122.017484 °
DWR ID	DWR_LD0001G_01_s_2016_40				
Comment Code					
PR : Prunings					
Inspector Comment					
Remove prunings at LS toe.

View of the prunings along the landside slope and toe.

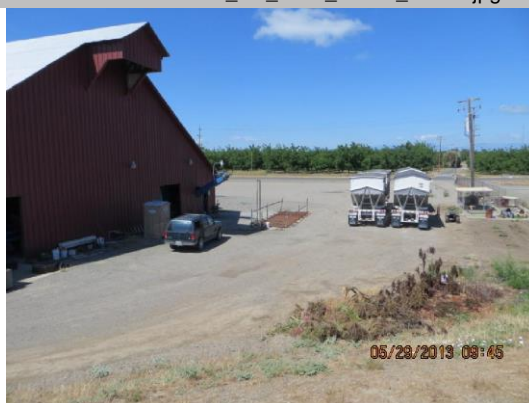
Photo 2 of 3 : UCIP_SP_2018_14324_23563.jpg

Concrete sump next to barn off LS toe.

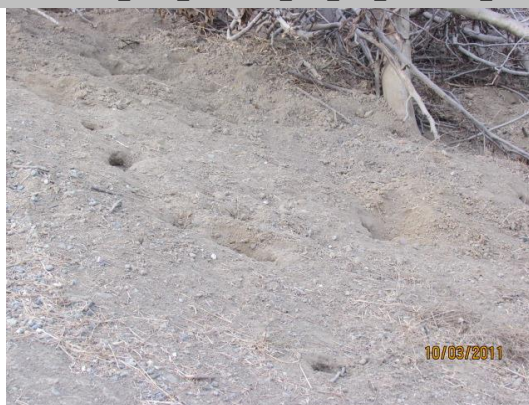
Photo 1 of 1 : SP_2018_LD0001G_432_395_20180305_00043.jpg

LM Start	3.88	Rating **	A/W	Issue No.	395
LM End	3.88	Issue Type +	Ma	Location *	LS
Category	Earthen Levee			GPS Latitude/Longitude	
				Start	End
Item	Animal Control			39.523845 °	39.523845 °
				-122.010745 °	-122.010745 °
DWR ID	DWR_LD0001G_01_s_2012_395				
Comment Code					
A3 : No rodents visible, but rodent burrows visible; need to backfill and compact or grout burrows.					
Inspector Comment					
Unable to see the rodent holes because of the prunings pile. Backfill and compact the rodent holes on the landside slope.

View of the rodent holes along the L/S toe.

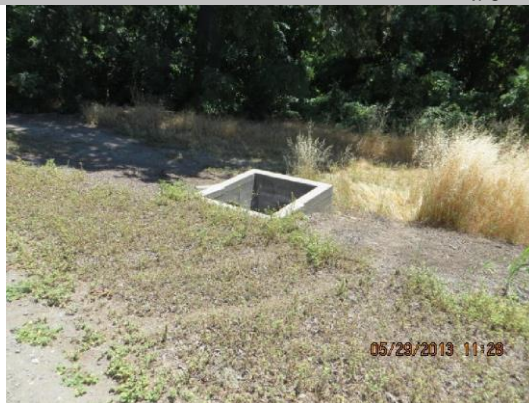
Photo 1 of 3 : UCIP_SP_2018_51463_27386.jpg

Comment Code					
Inspector Comment					
FS_ID:51463 DS_ID:22904 EP_NO: 9572 Repair Type: Urgent Crossing Status: Found UCIP Comments: 12/21/2016 Flap gate on WS does not appear to be broken however, flap gate does not fully close due to a 3-inch aluminum pipe sleeve through larger pipe. Need to remove 3-inch pipe in order to have WS flap gate close and to be compliant with Title 23. (O. Magana - DWR UCIP)05/29/2013 Broken flap gate and Concrete headwall on LS toe possibly tilting. Also a 3-inch alluminum irrigation line through the pipe. (W. Wylie - DWR UCIP) FIELD_STRUCT_DESC: 18-inch steel drainage pipe through the levee, 7.3 feet below the crown. Flap gate in 6-inch by 6-inch concrete box located on the waterside (WS) end. Concrete headwall located on the landside (LS) toe. (18-inch pipe [HLM 4.05] authorized under Automatic Board Order (ABO) issued as Permit No. 9572, 1974 - Henry and Annabel B. Smith). [Additional Reference(s): DWR Levee Log, 1992. USACE Sacramento O&M Manual 140, May 1960, (HLM 4.05)]. FS Date: 12/21/2016

Distribution box on WS toe.

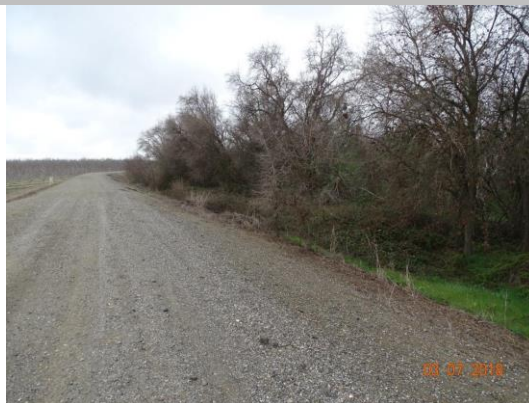
Photo 1 of 1 : SP_2018_LD0001G_432_68_20180312_00124.jpg

LM Start	5.71	Rating **	M	Issue No.	68
LM End	5.79	Issue Type +	Ma	Location *	WS
Category	Earthen Levee			GPS Latitude/Longitude	
				Start	End
Item	Vegetation			39.543345 °	39.544320 °
				-122.000428 °	-122.001012 °
DWR ID	DWR_LD0001G_01_s_2018_68				
Comment Code					
V2 : Remove the wild growth other than native grasses from the levee slopes.					
Inspector Comment					
Remove the vegetation from the waterside slope and toe.

View of the vegetation along the waterside slope and toe.

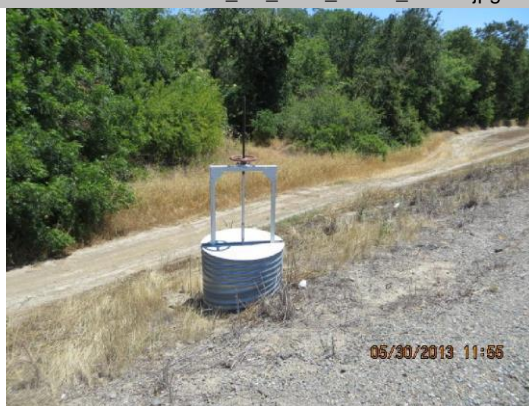
Photo 2 of 3 : UCIP_SP_2018_14384_23663.jpg

Slide gate in 36-inch CMP standpipe on WS slope

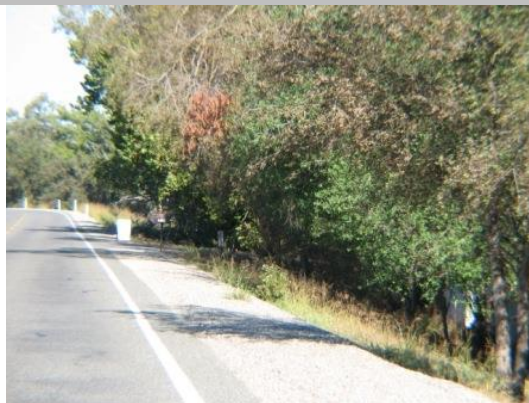
Photo 1 of 1 : SP_2018_LD0001G_432_20_20180305_00008.jpg

LM Start	8.05	Rating **	M	Issue No.	20
LM End	8.16	Issue Type +	Ma	Location *	WS
Category	Earthen Levee			GPS Latitude/Longitude	
				Start	End
Item	Trim / Thin Trees			39.576580 °	39.578187 °
				-122.004962 °	-122.005218 °
DWR ID	DWR_LD0001G_01_s_2012_20				
Comment Code					
T2 : Thin trees to allow visibility of the ground and room to flood fight.					
Inspector Comment

View of the trees and vegetation along the waterside slope of the levee.

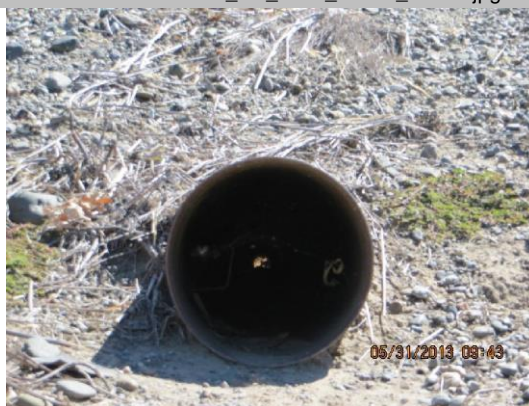
Photo 2 of 3 : UCIP_SP_2018_51285_23667.jpg

Pipe on LS slope.

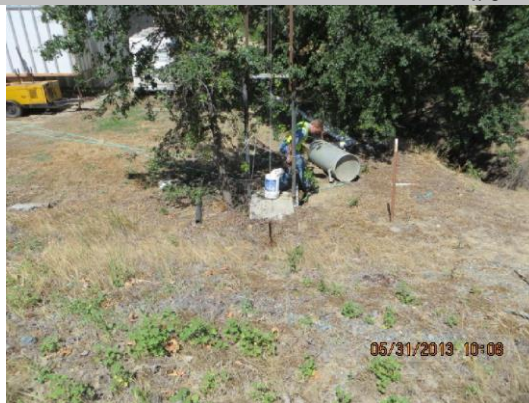
Photo 1 of 3 : UCIP_SP_2018_16204_27330.jpg

Pipe visible next to well with bucket over standpipe.

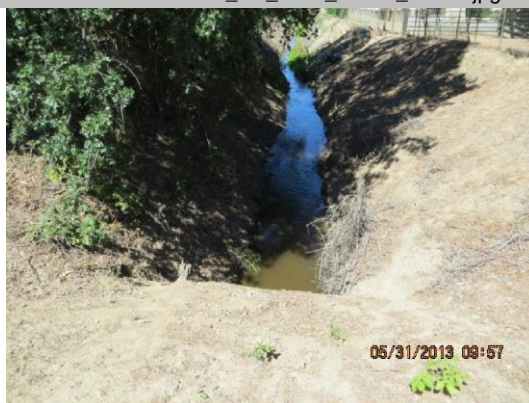
Photo 2 of 3 : UCIP_SP_2018_16226_27355.jpg

Drainage swale terminates at Concrete headwall for pipe.

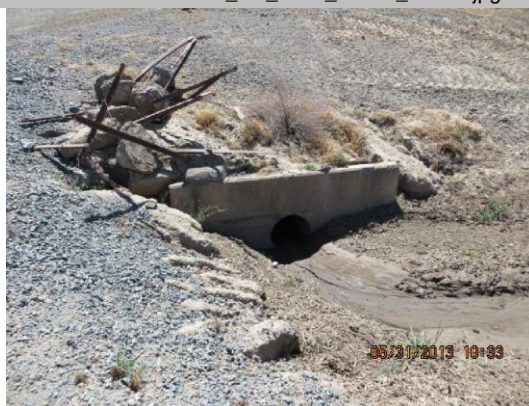
Photo 2 of 3 : UCIP_SP_2018_14390_23689.jpg

Concrete headwall and pipe at LS toe.

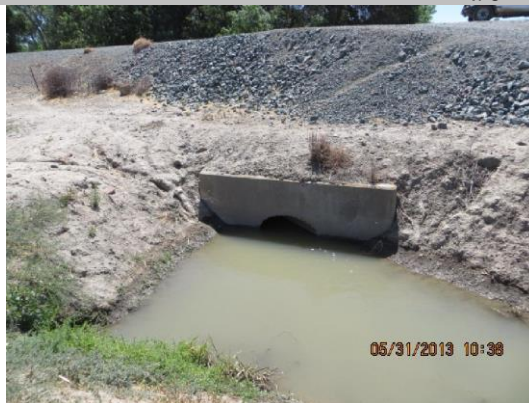
Photo 1 of 3 : UCIP_SP_2018_14559_23986.jpg

Pipe and headwall on LS toe.

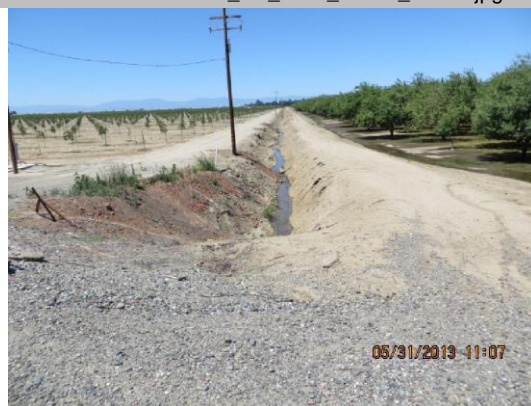
Photo 1 of 3 : UCIP_SP_2018_51286_24006.jpg

Drainage channel on LS toe.

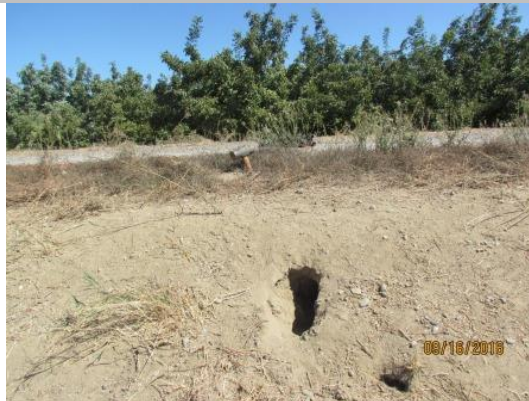
Photo 1 of 2 : SP_2018_LD0001G_432_79_20180305_00041.jpg

LM Start	11.66	Rating **	M	Issue No.	79
LM End	11.66	Issue Type +	Ma	Location *	LS
Category	Earthen Levee			GPS Latitude/Longitude	
				Start	End
Item	Animal Control			39.624112 °	39.624112 °
				-121.999933 °	-121.999933 °
DWR ID	DWR_LD0001G_01_f_2016_79				
Comment Code					
A3 : No rodents visible, but rodent burrows visible; need to backfill and compact or grout burrows.					
Inspector Comment					
Rodent holes on the landside slope and crown.

View of the rodent holes along the landside slope with large hammer sitting in the hole.
